## 3.0 DESCRIPTION OF THE INCIDENT

### 3.1 PRE-INCIDENT EVENTS

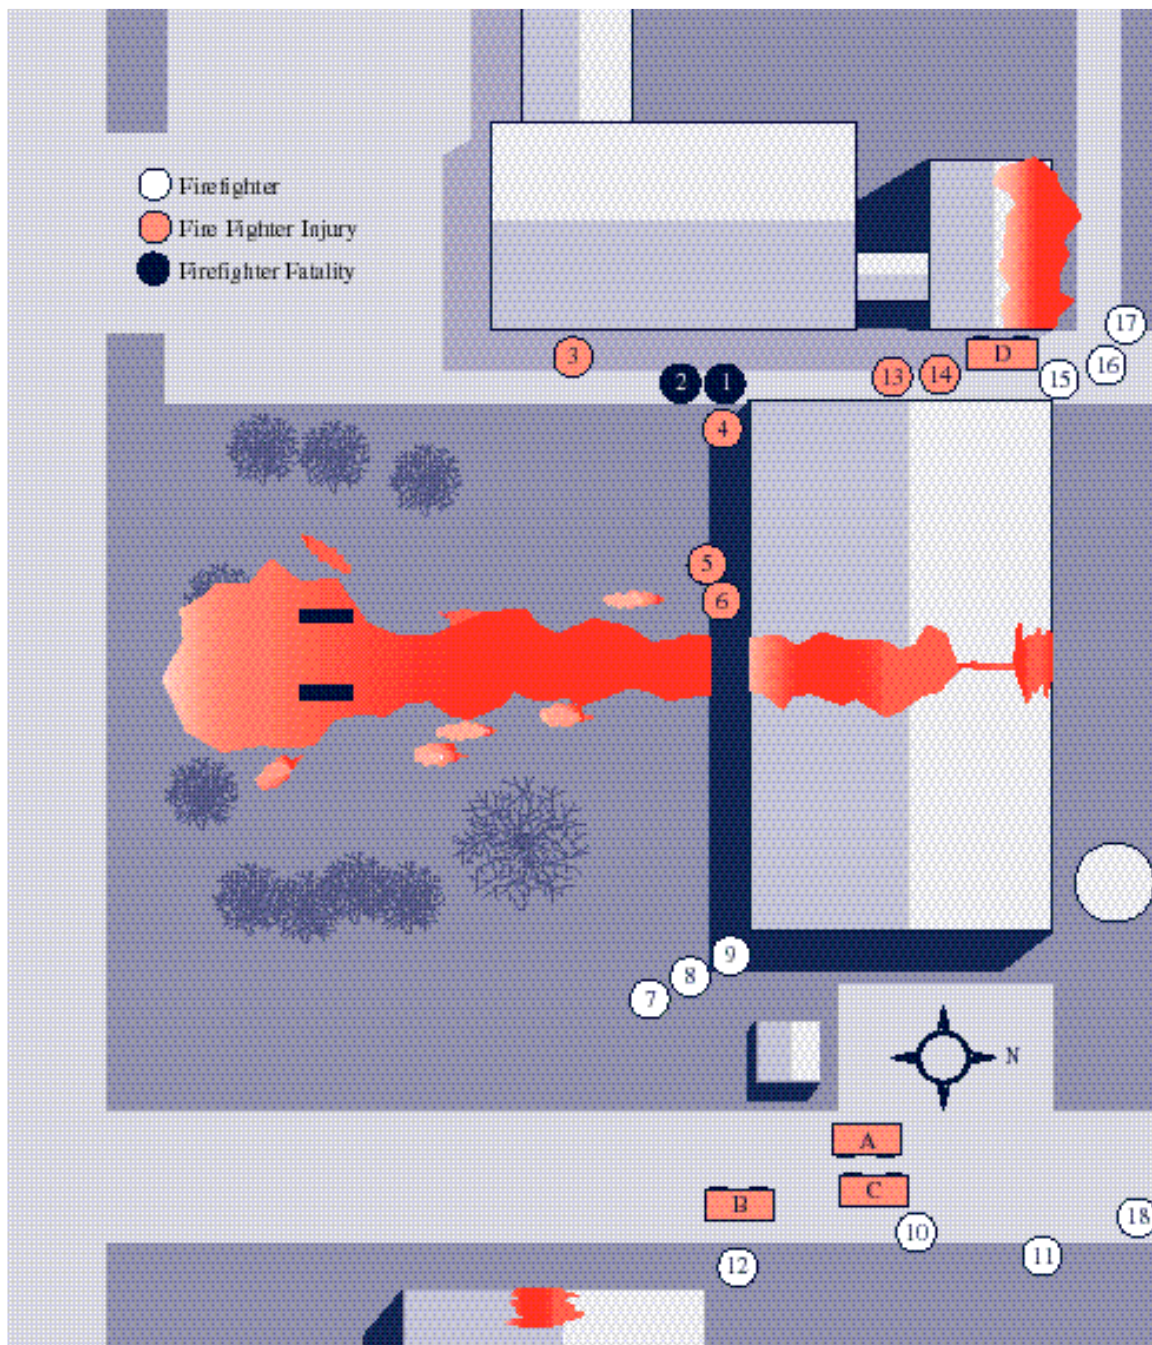
killing two volunteer firemen. The Iowa State Medical Examiner listed the cause of death in each instance as massive trauma to all body systems. The fire fighters who died were located about 100 feet from the northwest side of the tank, as depicted in Figure 8 (numbers 1 and 2). The tank piece that struck two of the fire fighters narrowly missed the Fire Chief (see Figure 8, number 4). Another large piece of the tank was propelled directly north, just missing two other fire fighters (see Figure 8, numbers 5 and 6). Seven emergency response personnel sustained injuries as a result of the explosion. These injuries ranged from scrapes and bruises to severe burns.<sup>15</sup> This explosion easily could have caused numerous additional fire fighter fatalities.

**Figure 8. Fire fighters (numbers) and Response Vehicles (letters) at the Time of the Blast (not to scale)**

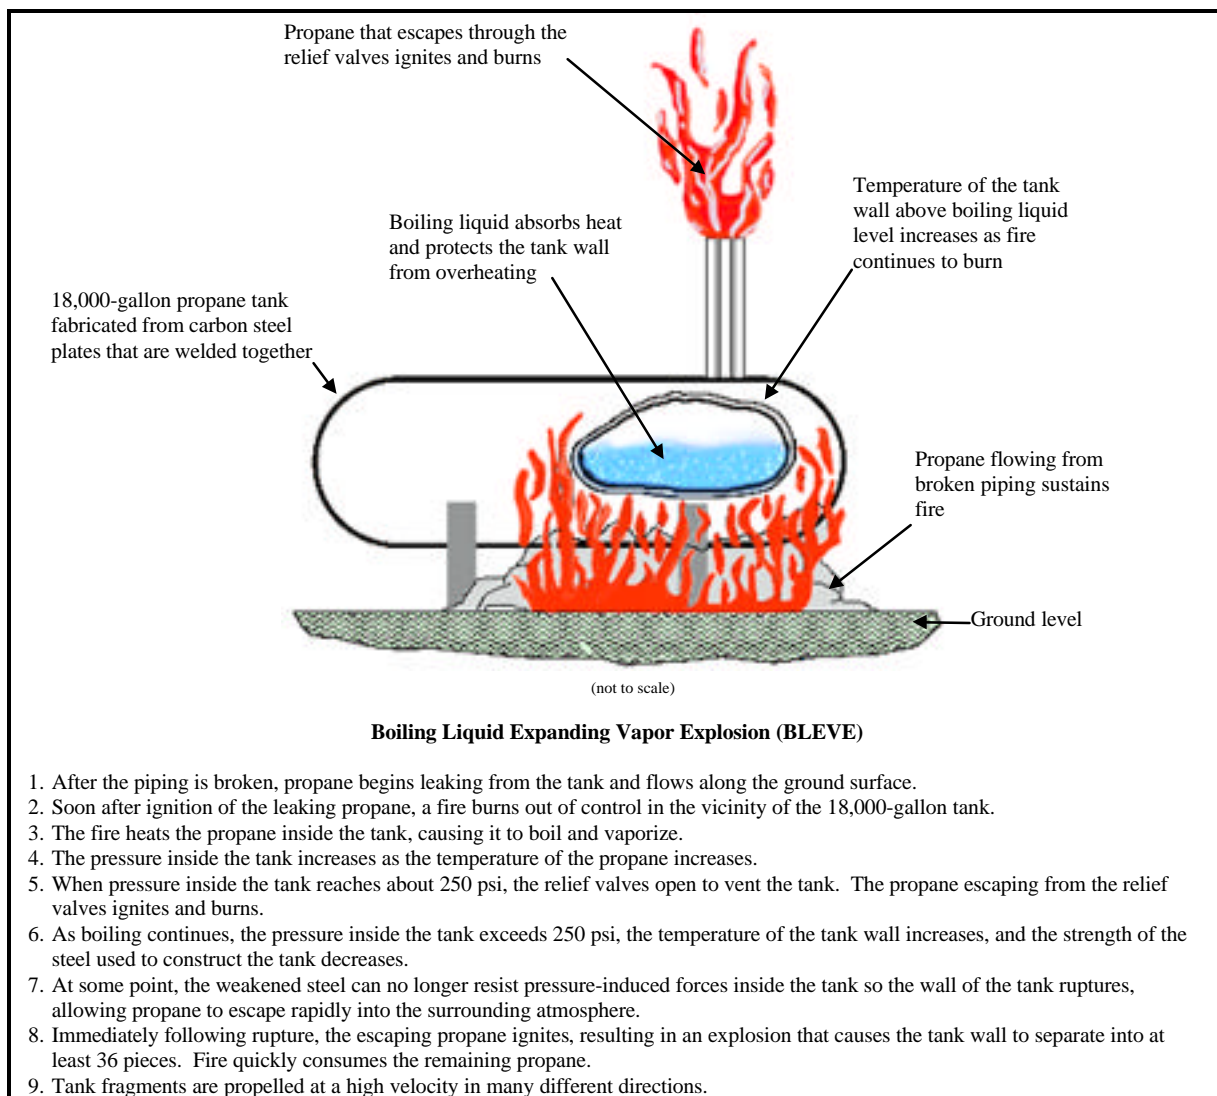
Immediately after the initial fracture in the tank wall, the following events occurred within moments. The remaining propane inside the tank began escaping into the surrounding atmosphere, where it vaporized almost instantaneously. As the liquid and vapors escaped, the tank wall continued tearing, allowing even more propane to escape. The propane ignited, and the explosion occurred. Tank fragments were propelled in all directions. Figure 9 shows the conditions that produced the BLEVE.<sup>18</sup>

**Figure 9. BLEVE**

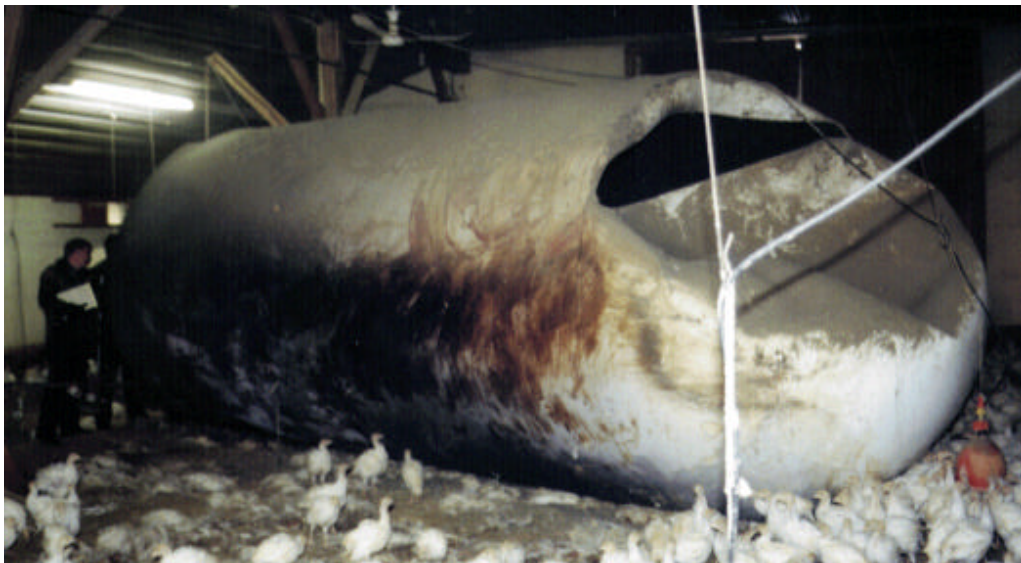
diameter) was propelled to the east, through the end of a turkey barn wall (see Figure 2, item 1f) and came to rest inside the barn (see Figure 10). This piece, which represented about one-half of the tank, caused the damage to the west end of turkey barn 1f, shown in Figure 11. A second large fragment traveled north, causing the damage to another turkey barn shown in Figure 12. (See also Figure 2, item 1g for location of the barn). Two other large pieces traveled in a northwesterly direction and landed between a workshop and a feed storage bin. One of these pieces likely caused the damage to the two-story workshop shown in Figure 13. Smaller tank pieces traveled in various directions. Some of these pieces were discovered in the grain fields that surround the property. A map that depicts the location of tank debris following the explosion is provided in Appendix C.

**Figure 10. Piece of 18,000-gallon Tank Inside Turkey Barn (1f)**

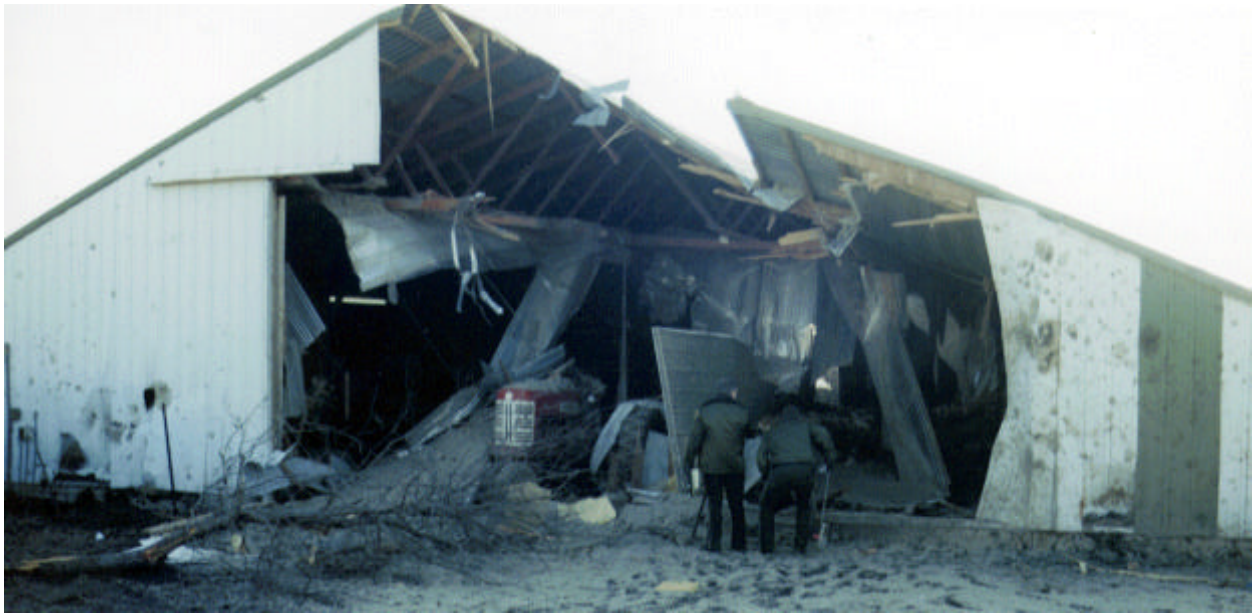
**Figure 11. Damage to West End of Turkey Barn (1f)**

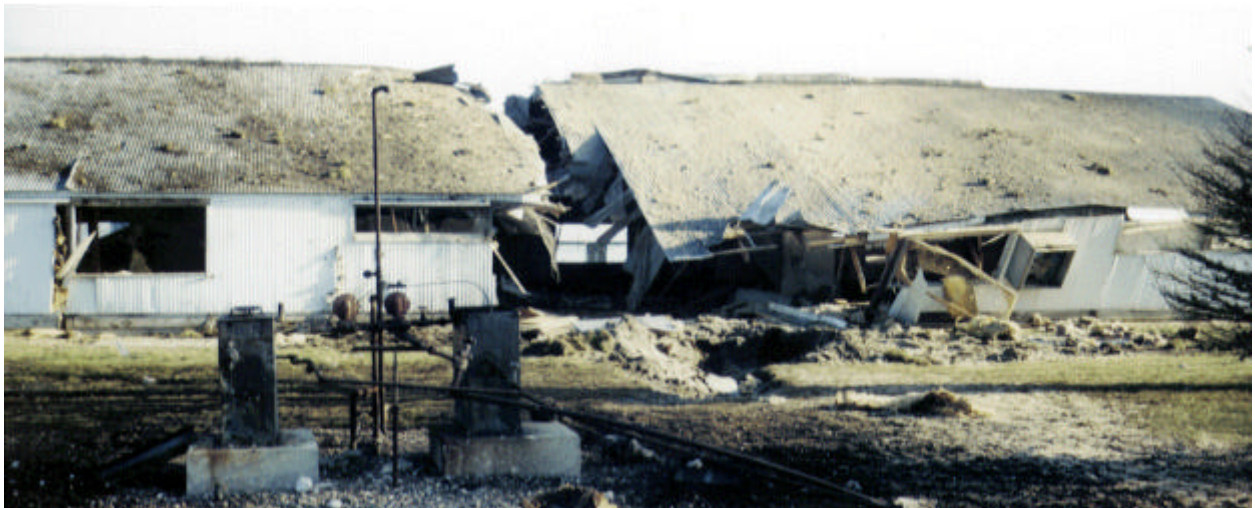
**Figure 12. Damage to Turkey Barn (1g) Caused by Impact of Large Tank Fragment**

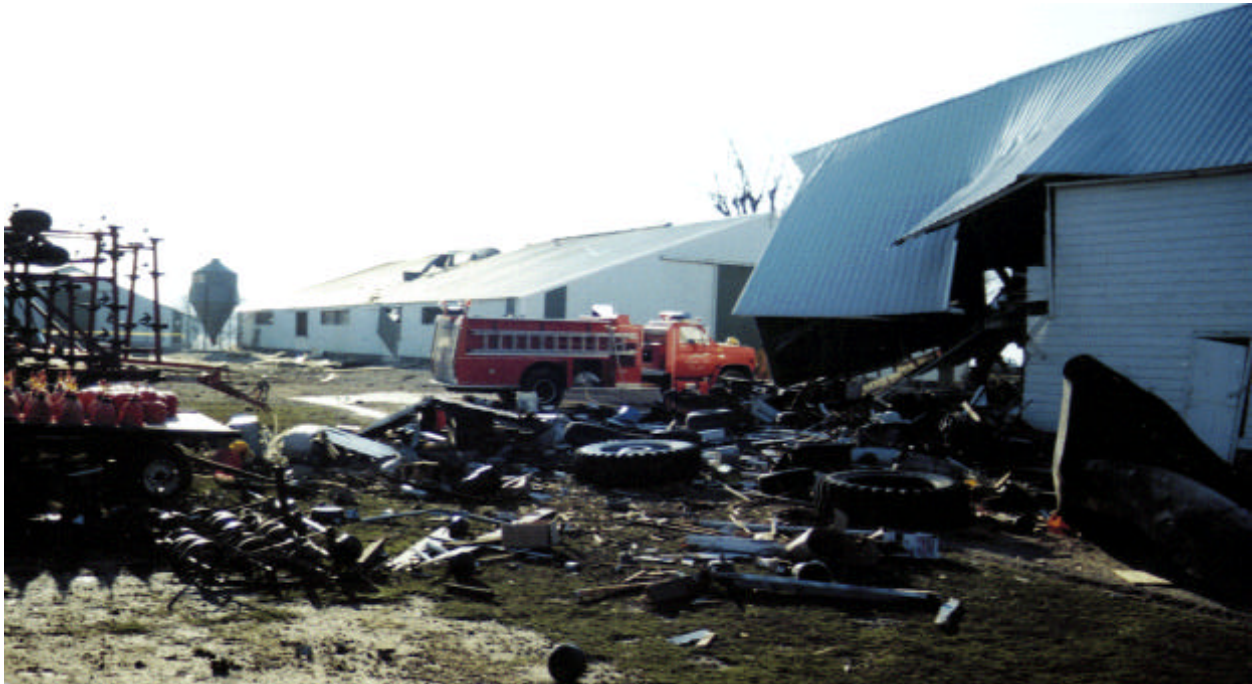
**Figure 13. Southeastern View of Damage to Workshop Caused by Impact of Large Tank Fragment**
